MICHIGAN DEPARTMENT OF ENVIRONMENTAL QUALITY
WATER RESOURCES DIVISION
JUNE 2016

STAFF REPORT

BIOLOGICAL SURVEYS OF SELECTED LOWER GRAND RIVER STREAMS
IONIA, KENT, MUSKEGON, AND OTTAWA COUNTIES, MICHIGAN
AUGUST-SEPTEMBER 2014

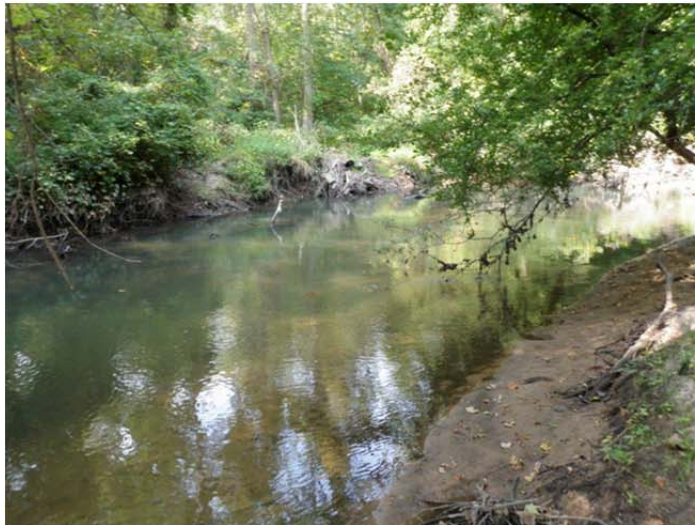
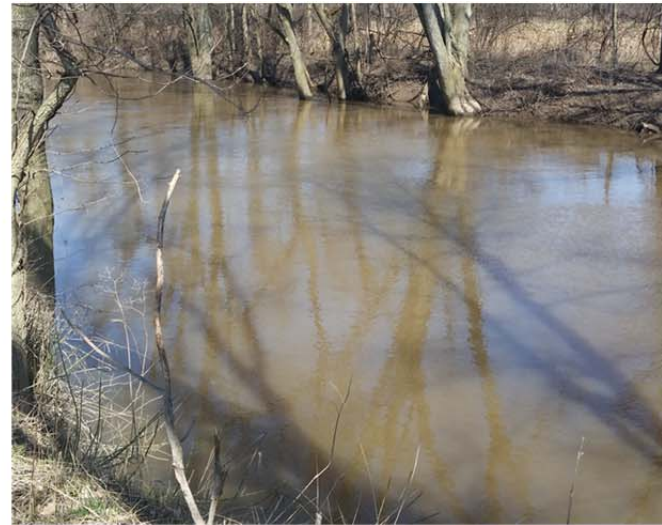
Figure 4. Crockery Creek, Ensley Road site (Station 8). Photo on left is from August 2009 and photo on right is from March 2016.

At Station 8 the macroinvertebrate community scored a high acceptable (3; Table 4), although habitat was marginal (68; Table 6). The macroinvertebrate community was dominated by Amphipoda and Brachycentridae. Three Ephemeroptera and five Trichoptera families were found. While Amphipoda are facultative, Brachycentridae are considered to be very sensitive to disturbance (Voshell, 2002). Although in-stream large woody debris was sparse at this site, Brachycentridae and other Ephemeroptera and Trichoptera taxa were colonizing what little stable habitat was available. The large woody debris that was present was largely out of the water and lying parallel to the stream, indicating flashy flow conditions (Figure 4). The banks were very steep and largely devoid of vegetation with active erosion occurring on both sides. This section of the creek appeared to have been historically dredged and channelized. Along the right bank was Ensley Road, which is a gravel/dirt road and along the left bank was a small row crop field. Crockery Creek runs parallel to Ensley Road for over 0.1 mile. Large trees were growing immediately alongside the stream, which provided good canopy cover. The sediment

type was mostly sand (95% visual estimate). The greater surrounding area contains a mix of forest and agricultural land use. This site was sampled in 2009 with the macroinvertebrate community scoring acceptable (0) and habitat scoring marginal (104; Rippke, 2011).

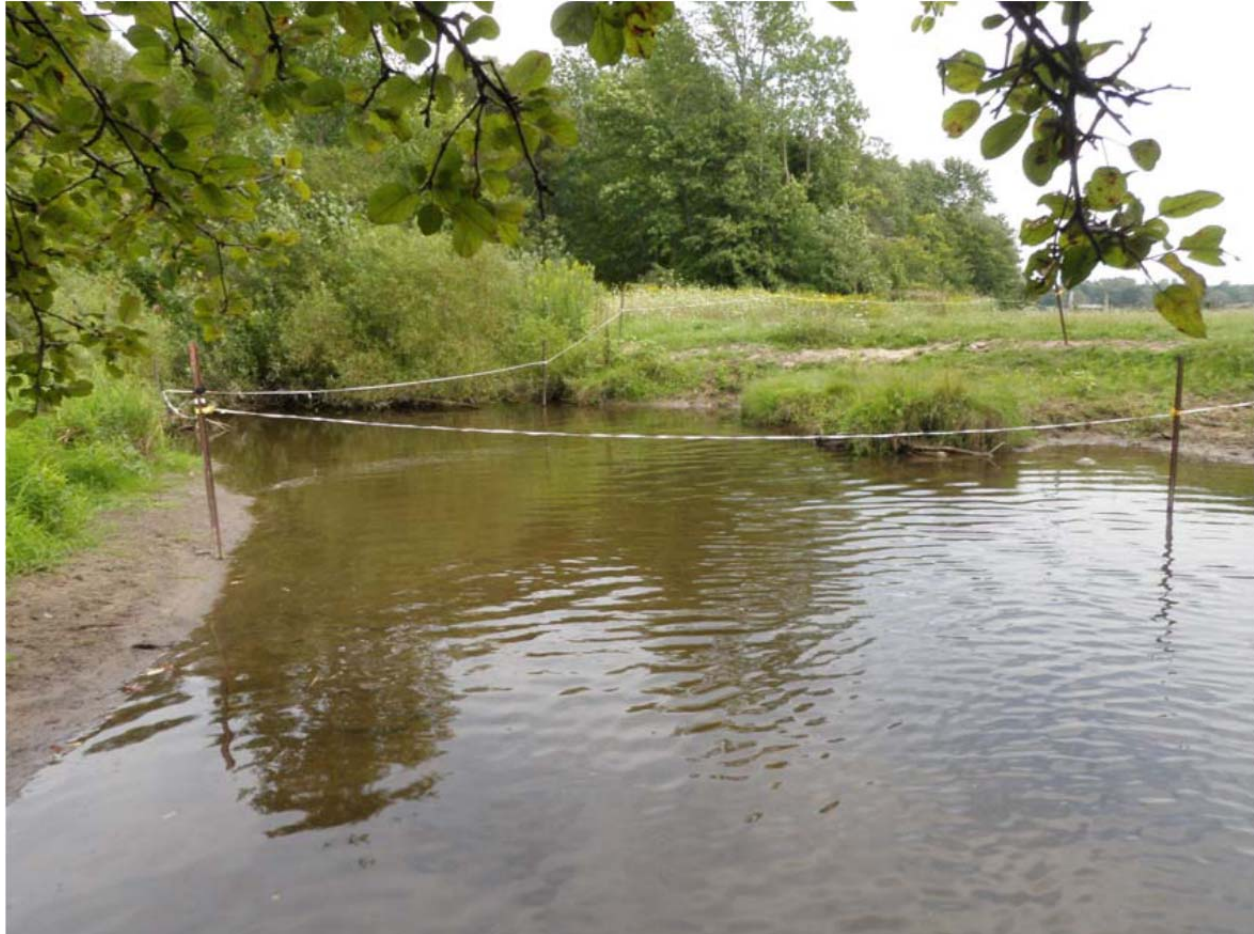
Figure 5. Photo of restricted, but direct access for horses in a section of North Branch Crockery Creek near 24th Avenue during 2009 survey.

At Station 16 the macroinvertebrate community scored acceptable (1; Table 4) and habitat scored good (119; Table 6). This site was sampled in 2009 and macroinvertebrates scored poor (-5) and habitat scored low good (106). In 2009, the macroinvertebrate community was dominated by Amphipoda and only one Ephemeroptera and one Trichoptera family were collected. In 2014, the macroinvertebrate community was still dominated by Amphipoda; however, three Ephemeroptera and three Trichoptera families were collected. The current results indicate moderate disturbance at the site, but the conditions may be improved since the last sampling event. During the 2009 survey, biologists observed that horses were allowed access to a section of the stream (Figure 5; Rippke, 2011).

The restricted, but direct horse access to the stream caused localized bank erosion as well as localized stream bed disturbance. The direct access was reported to Grand Rapids district staff who worked with the Michigan Department of Agriculture and Rural Development to restrict all access to the stream. During the 2014 visit, the fence was set back from the stream and vegetation was starting to regrow in areas along the bank where bare soil was present in 2009. Rootwads were extensive and undercut banks, overhanging vegetation, and large woody debris were moderately available. The stream showed signs of flashiness though, with moderate amounts of sediment deposition and bank scour. Riparian vegetation along the stream is reduced by a crop near one bank and the horse pasture along the other bank. In some areas
